TEXAS NATURAL RESOURCE CONSERVATION COMMISSION
WATER QUANTITY DIVISION
DAM EVALUATION REPORT

INVENTORY NO. TX-3755 WATER RIGHT AUTHORIZATION A-2302 / P-2076

DAM Lake Charmaine Dam

EVALUATION DATE January 28, 1998

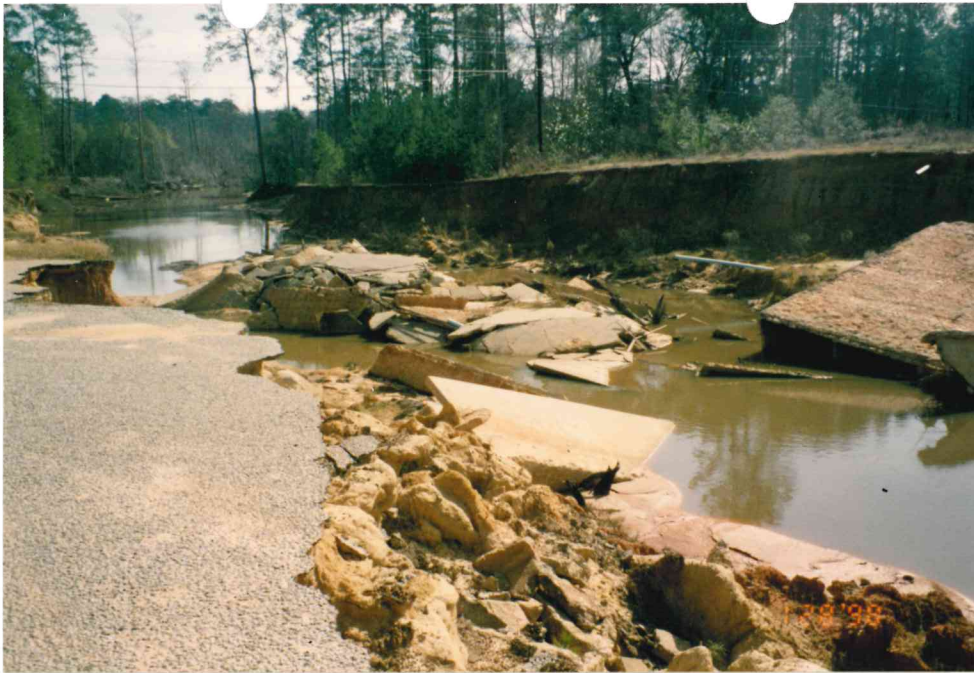
During the inspection of the dam it was noted that the spillway had been completely washed out. The lake is empty and will remain so until the owners obtain the financial resources to rebuild the dam. The concrete structure reportedly overtopped and was undermined which resulted in the whole structure tipping over and breaking up as the flood wave pushed it downstream. The resulting breached spillway area is now essentially a 100-foot wide discharge channel for the creeks that flow into Lake Charmaine.

Photo No.1: View of the destroyed concrete spillway. This channel is approximately 100-feet wide.

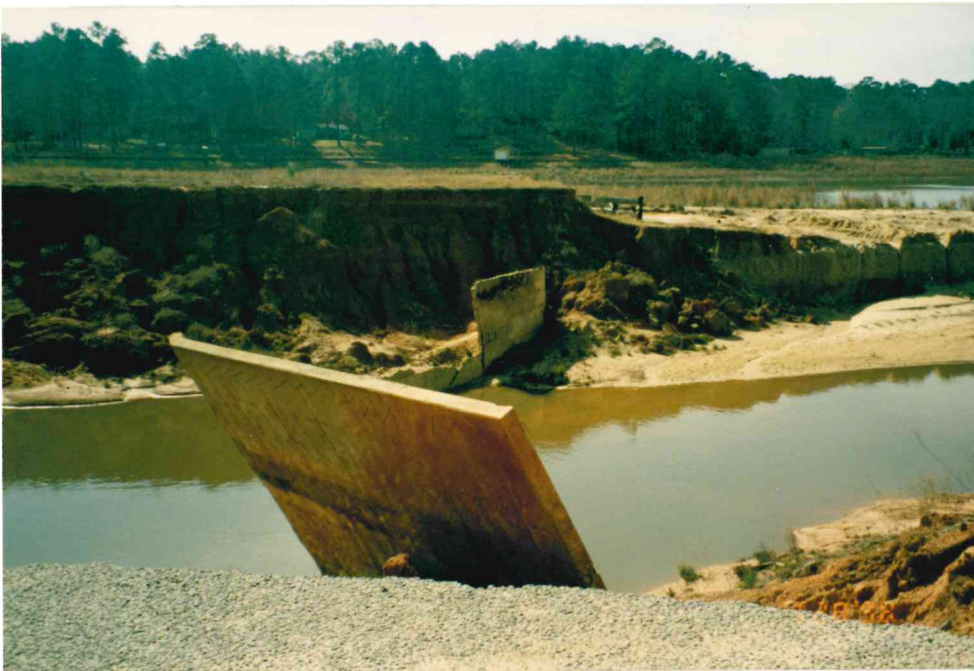
Photo No.2: This is a view of the remnants of the head wall for the concrete spillway. The previous photo is located to the left of this photo.

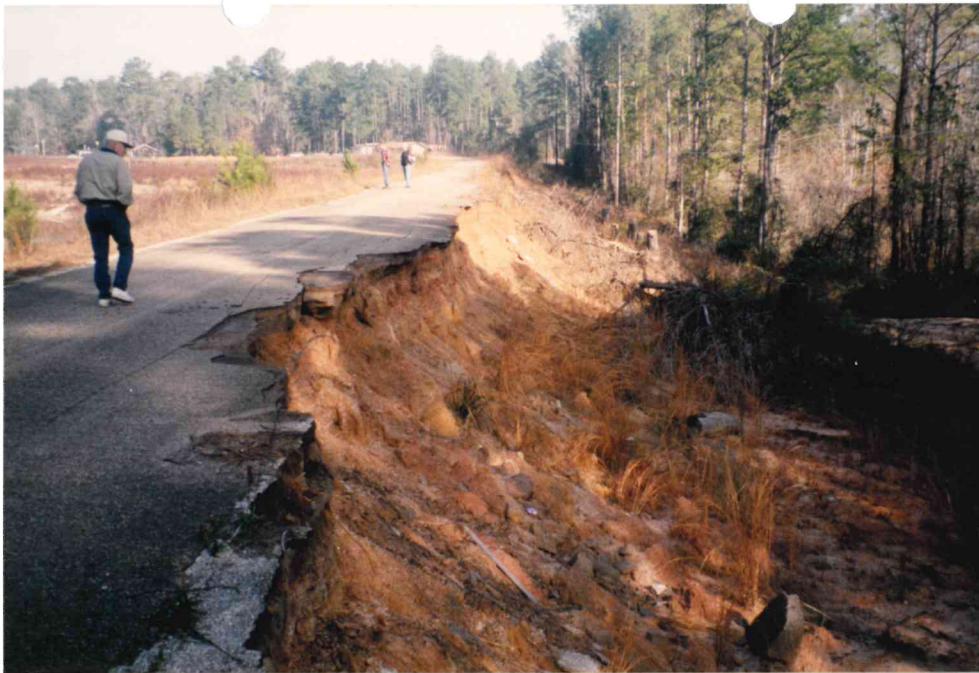
Flood flows were approximately three feet deep over the left abutment area. The IPOIA clubhouse was flooded along with many homes located along the left shoreline of the lake. The main embankment experienced approximately two to three feet of overtopping which resulted in significant erosion of the downstream slope. Many large trees were uprooted and toppled and an erosion scarp formed which varies from four to eight feet. Most of the downstream slope has been washed away. The owners have cleared some of the trees from the downstream slope and toe area in an effort to salvage salable timber and to begin removing the flood debris.

Photo No.3: View of the downstream slope of the embankment. Note that a good portion of the roadway has been destroyed and much material has been eroded from the downstream slope.

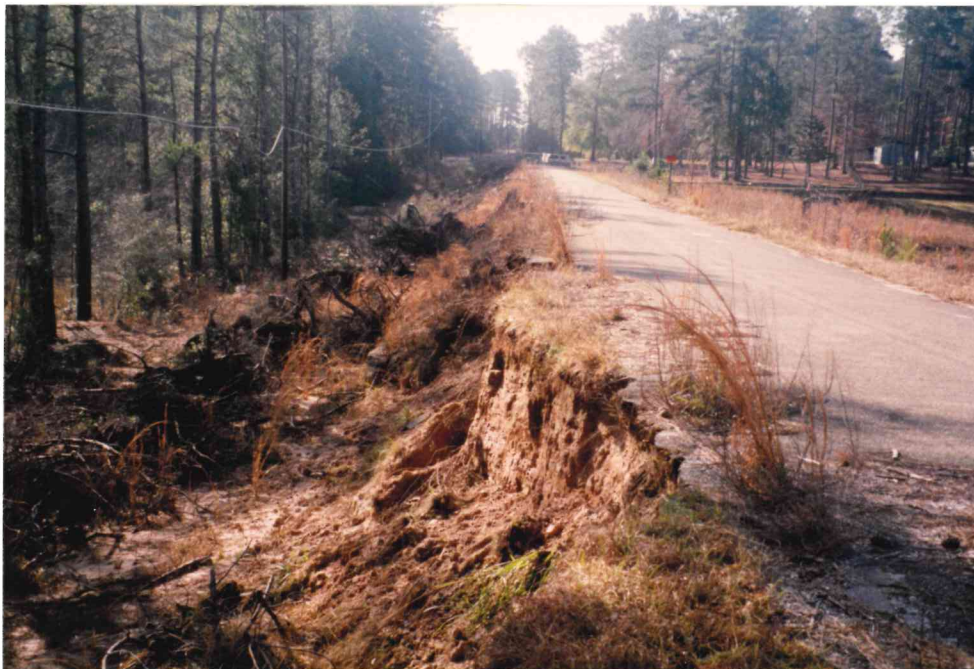
Photo No.4: This is a view of the damage that occurred to the downstream slope. Note that the erosion scarp is approximately eight feet high.

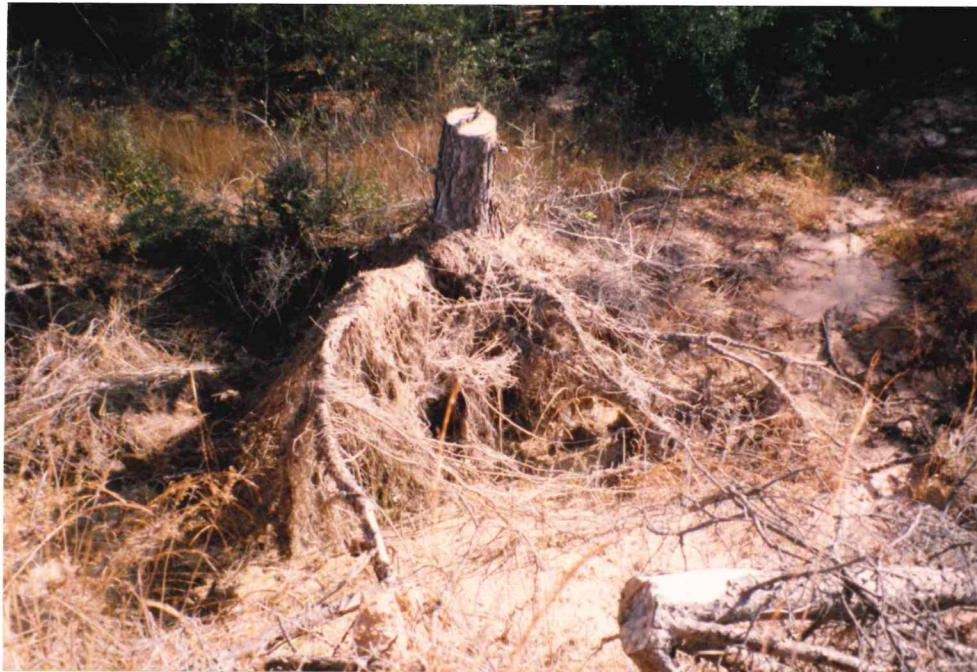
Photo No.5: This is a view of the downstream slope where trees were removed by the owners after the root balls had been exposed by erosion on the downstream slope.
